Recent 20-Hurricane Tests on Samson Subropes

**Summary of Test Results and
Implications for a Rope
Remaining Life Model**

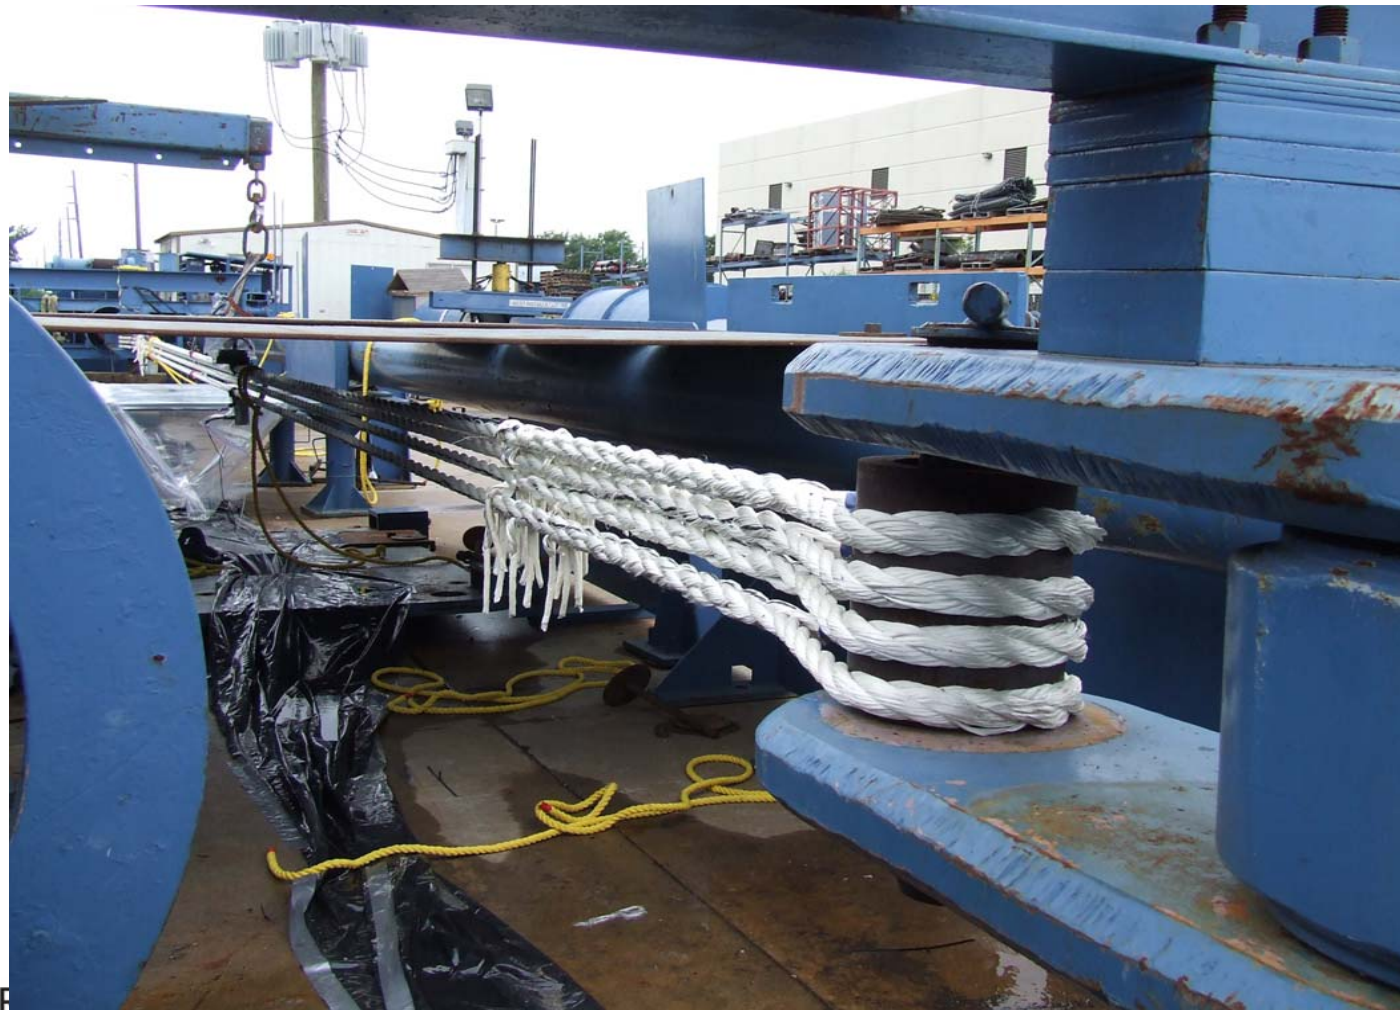
Cycling 4 Subropes in Parallel

- In an MMS project in progress, we subjected Samson subropes to the equivalent of 20 Hurricane Katrinas – 20,000 cycles of 60%/30%.
- 20 Hurricanes, the equivalent of one Hurricane Katrina making a direct hit each year for a 20-year life, caused a measured reduction in breaking strength of about 6%.

Samson Subrope Test Summary		
Sample	"New" Rope Break Strength	"Cycled" Rope Break Strength
1	79.19	75.56
2	80.45	74.21
3	80.36	76.24
Avg. Break, Kips	80	75.34
COV	0.88%	1.37%
